## SUBJECT: Kingpin Maintenance and Replacement Recommendations

### KINGPIN MAINTENANCE:

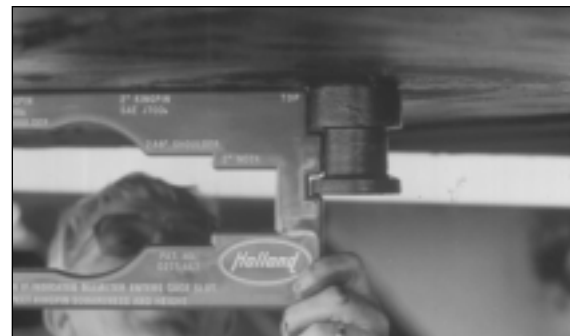
FIGURE 2

Using a Holland Kingpin Gage, check the length as shown in *Figure 2*.

If a lube plate is used in your operation, make sure to check the kingpin length. The kingpin must be sized to compensate for the thickness of the lube plate.

For more information, see Holland Service Bulletin XL-SB4. Otherwise, the kingpin will be too short. If the kingpin length is improper, the kingpin should be replaced.

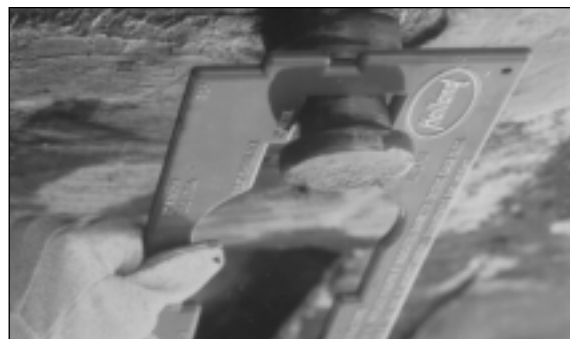
FIGURE 3

Using a Holland Kingpin Gage, check the wear on both the 2" and 2.88" diameters. Wear of 1/8" (.13") is indicated if the appropriate diameter enters the gage slot. Replace the kingpin if the gage slides into the appropriate gage slot (see *Figure 3*).
